FINAL
Coal Ash Impoundment –
Specific Site Assessment Report
PPL Montana
Colstrip Power Plant

Submitted to:
Lockheed-Martin Corporation
2890 Wood Bridge Avenue
Building 209 BAYF
Edison, NJ 08837

Submitted by:
GEI Consultants, Inc.
6950 South Potomac Street, Suite 300
Centennial, CO 80112

September 2009
Project 091330

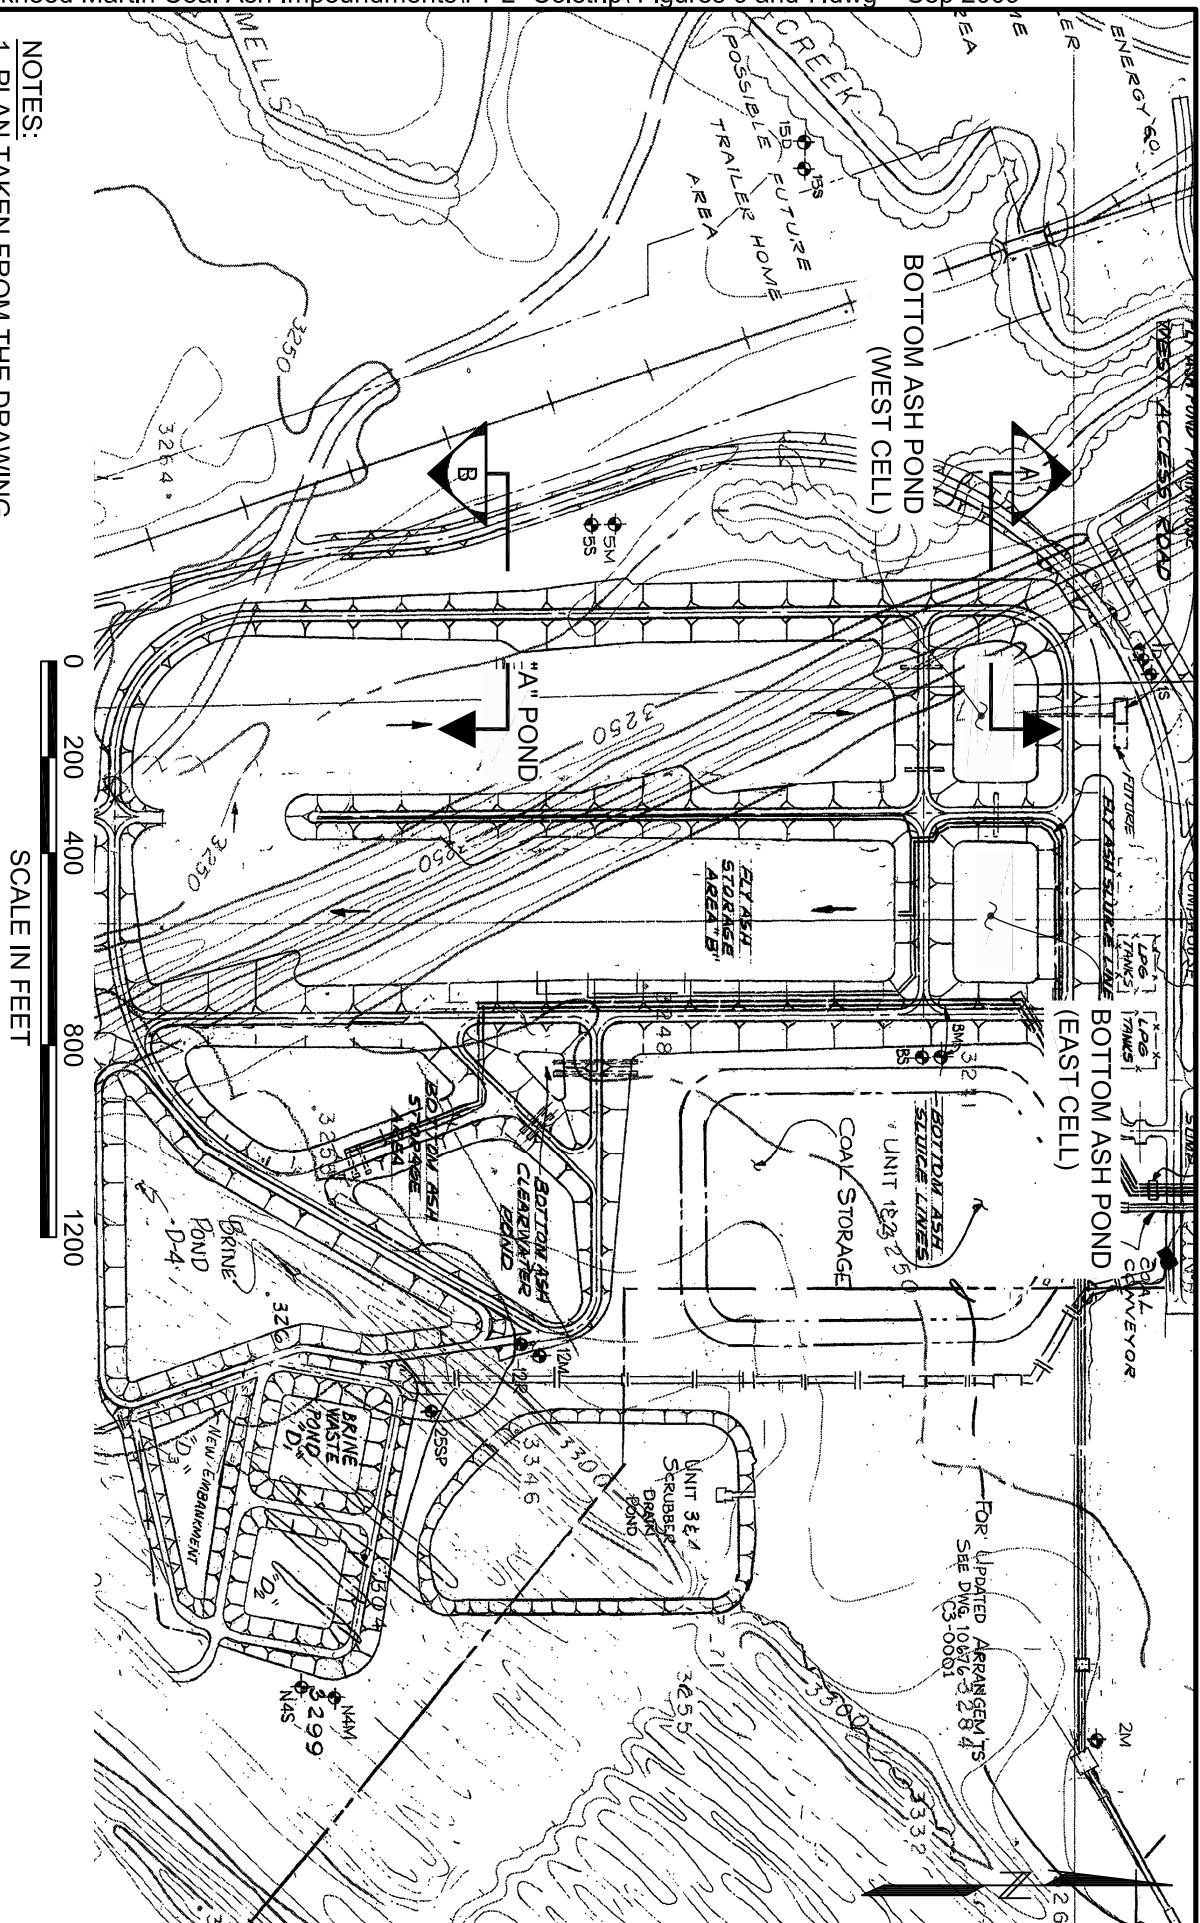
Figure 6

We based the embankment geometry for the slope stability analyses on the cross sections shown in Figures 6 and 7. We analyzed Sections A and B as representative of the west embankment, which impounds the Units 1 & 2 Bottom Ash Ponds and Pond "A". Soil parameters were assumed to be the same as those used for design of the STEP Dam (Bechtel, 1979). Bedrock depth was estimated from the Portage, 2005 report on design of the "B" Bottom Ash Pond and was assumed to be at El. 3,217. Piezometric surfaces were estimated using conservative assumptions. The soil material properties adapted from the STEP design are listed in Table 3.

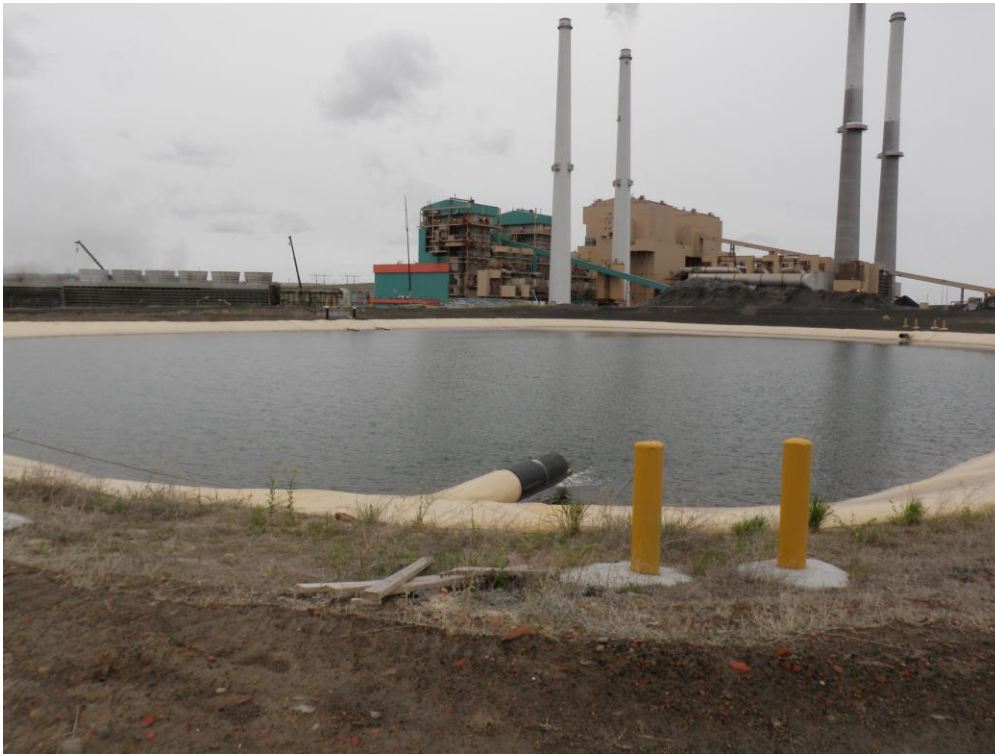
Photo 1: Units 1 & 2 Bottom Ash Ponds: west cell, general view looking northeast from southwest corner of pond.

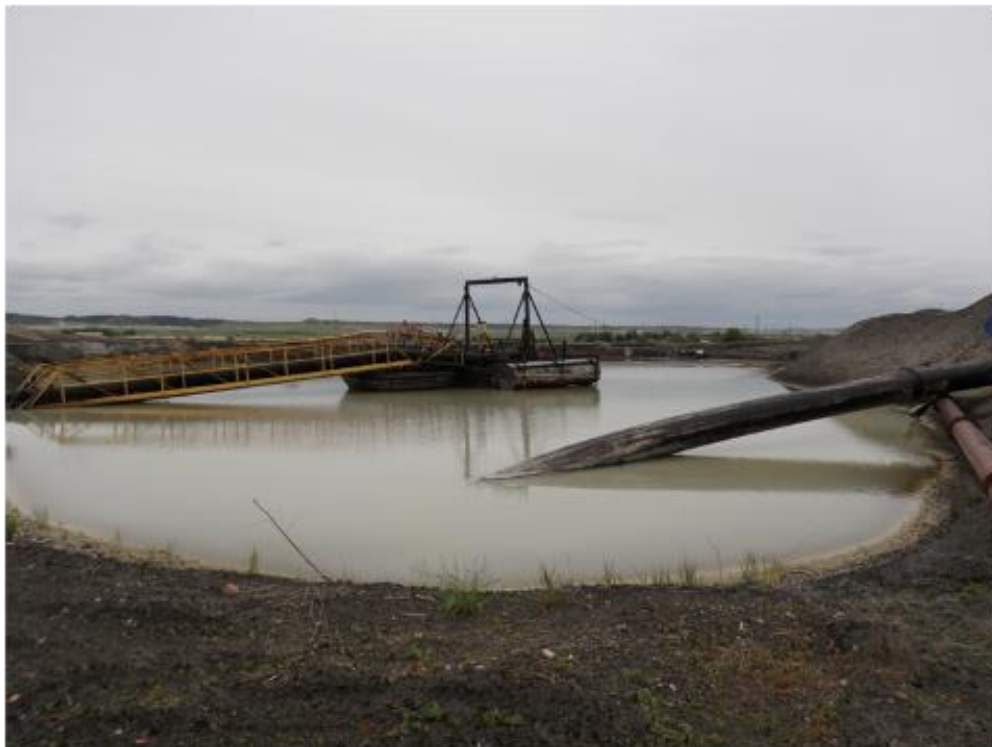
Photo 2: Units 1 & 2 Bottom Ash Ponds: east cell, looking west. The east cell has a clay lining. Note the out-of-service pump barge and associated pipes.

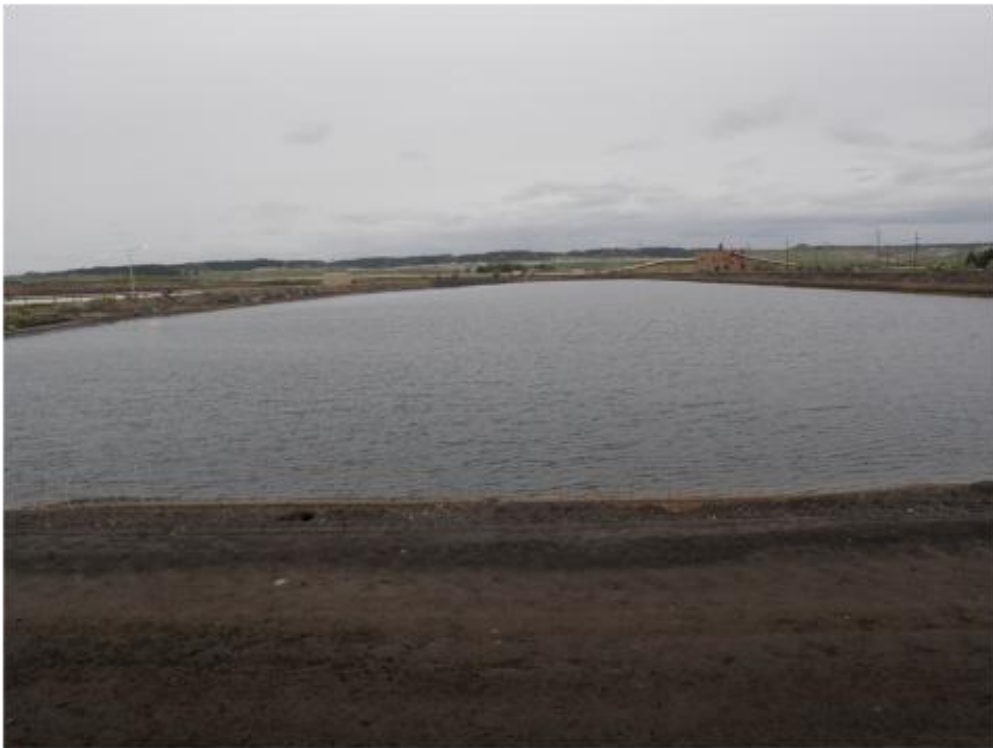
Photo 14: Units 1 & 2 "A" Pond: General view of pond from north embankment, looking south.

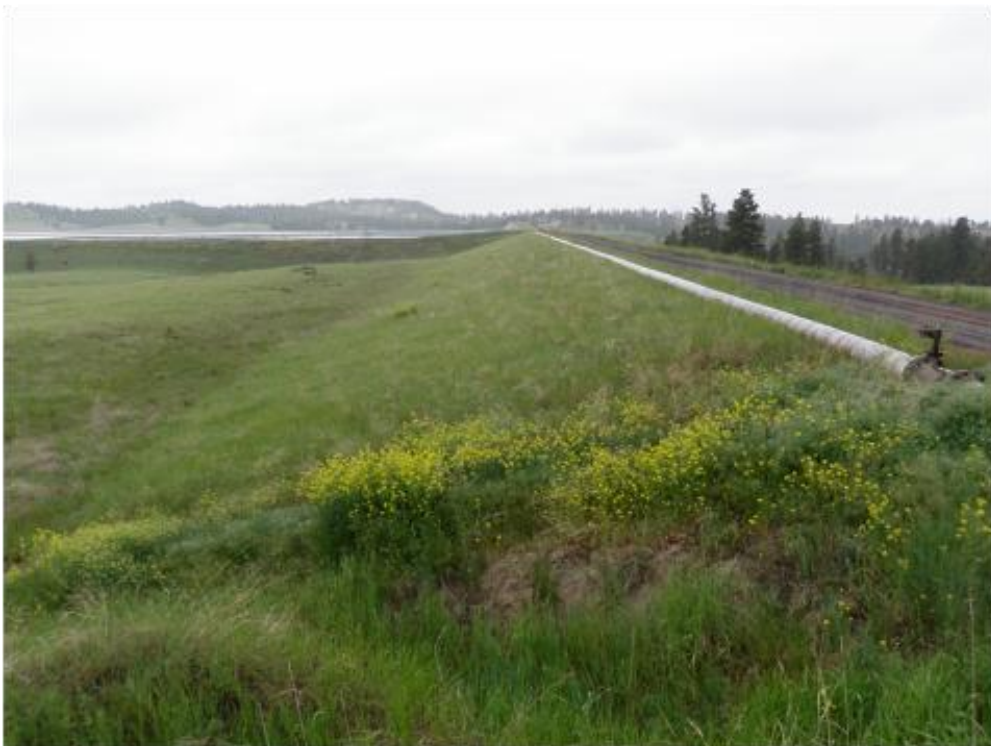
Photo 18: Units 1 & 2 STEP Dam: looking along upstream slope from near the right abutment. Note cell D has not been put in service. At right abutment looking northwest – upstream slope

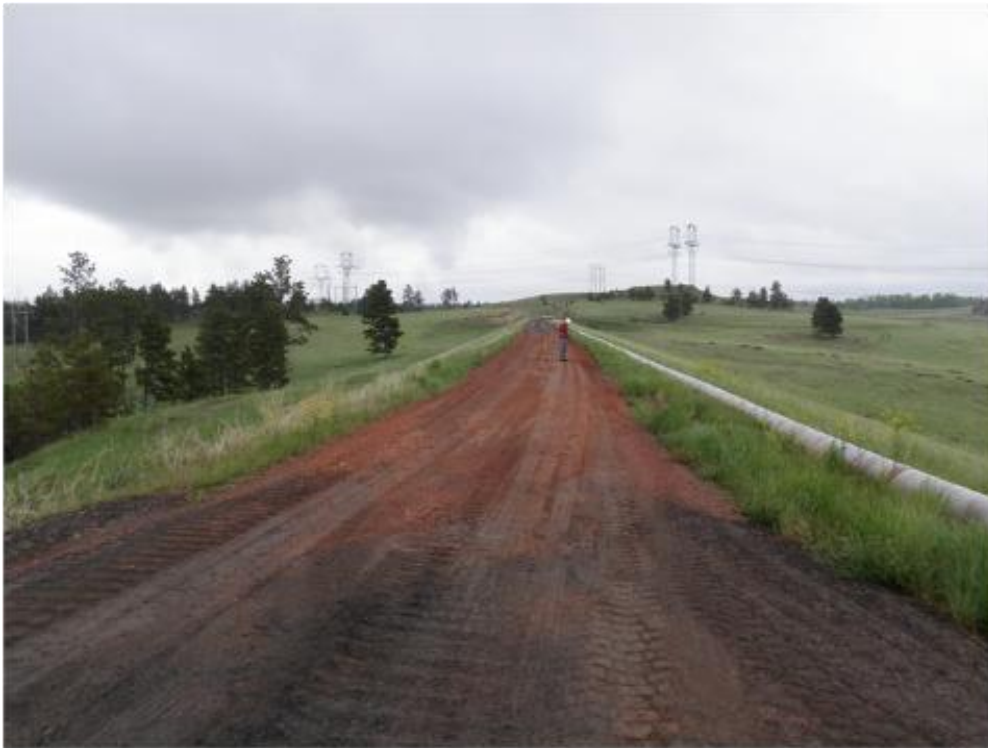
Photo 19: Units 1 & 2 STEP Dam – looking to right (southeast) at dam crest. Note the upstream cell at right (cell D) has not been put in service.

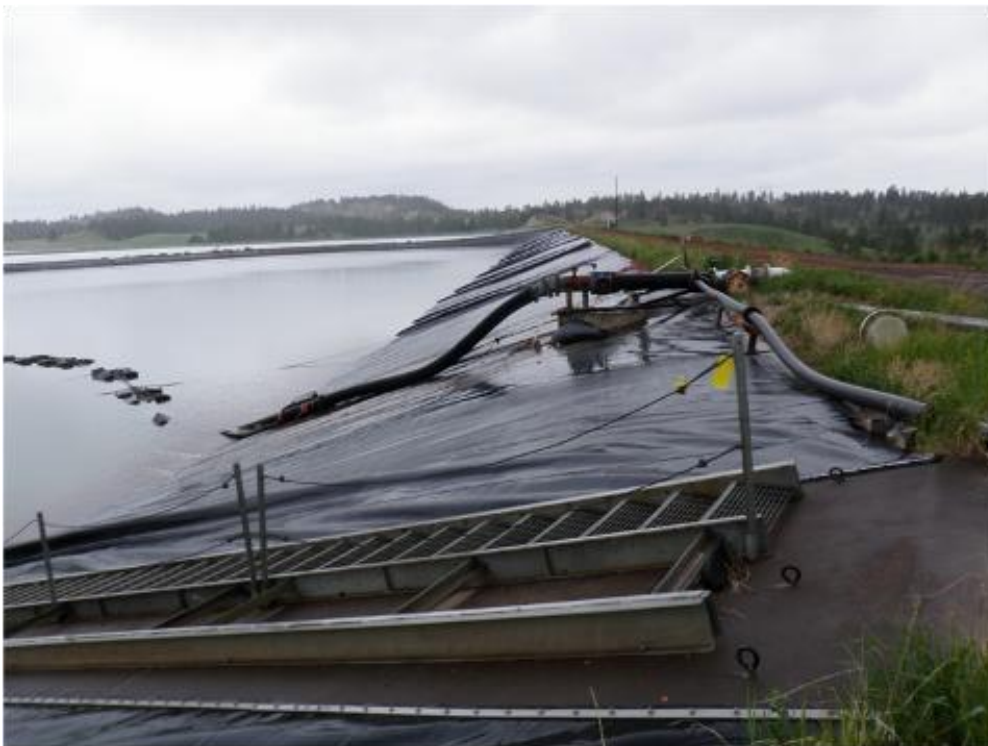
Photo 20: Units 1 & 2 STEP Dam – upstream slope at clearwell, looking to left. Note RFP liner.

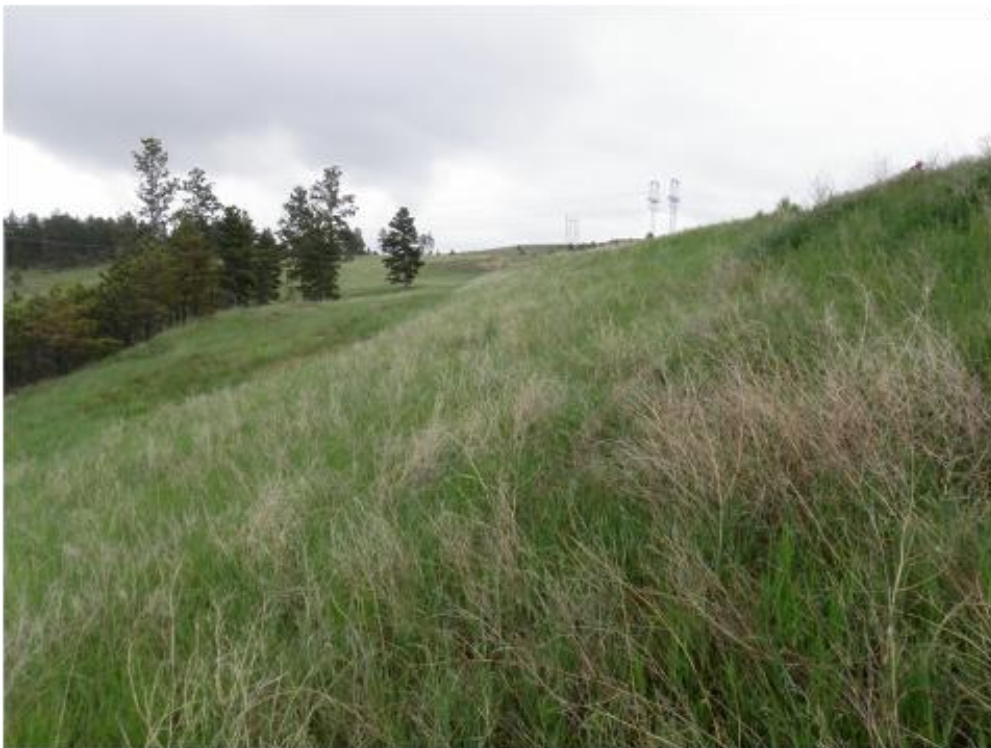
The downstream slope of the embankment is well-vegetated, which provides some erosion protection (Photos 23-24). No signs of major instability were observed along the downstream slope. Some erosion rills caused by surface water were observed in the groin near the right abutment (Photo 25). Stormwater flows across the downstream area near the right side of the dam toe due to runoff from a contributing drainage area located southeast of the dam.

Photo 23: Units 1 & 2 STEP Dam: downstream slope, looking to the right from mid-height near the center of the dam.

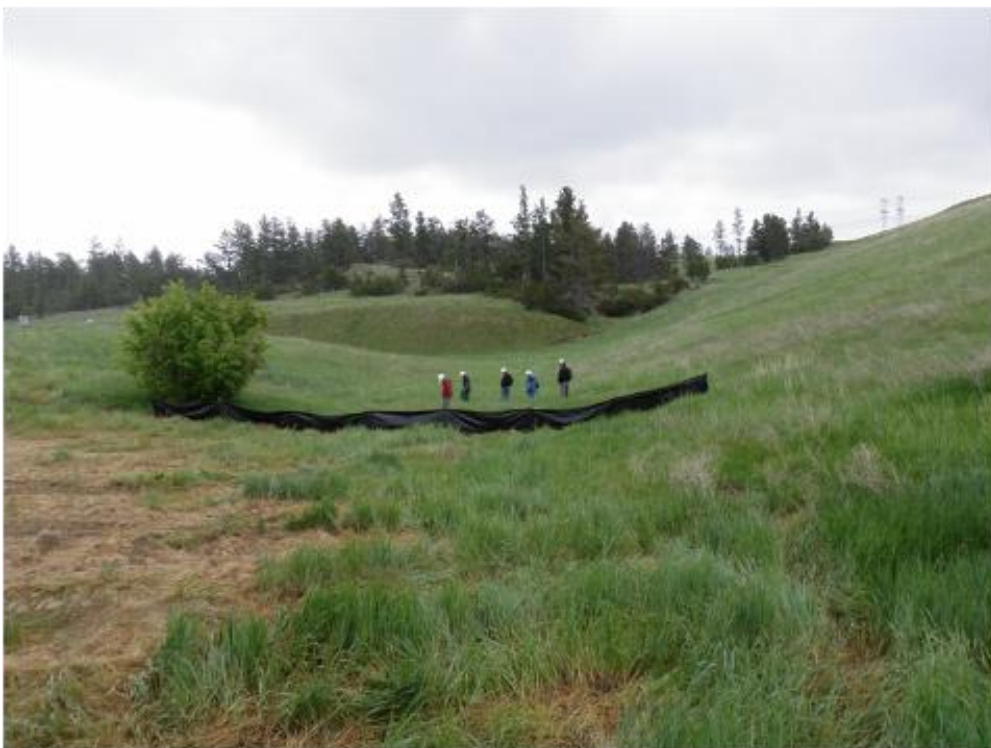
Photo 24: Units 1 & 2 STEP Dam: downstream toe, looking to the right from near the center of the dam.

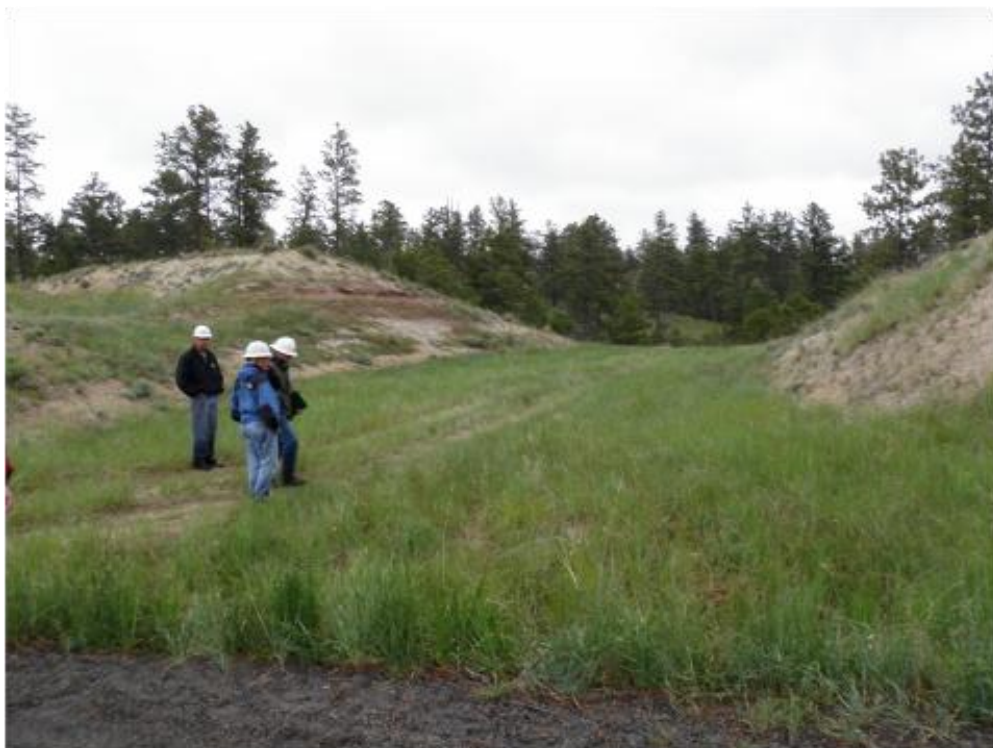
The emergency spillway beyond the left abutment of the dam appeared to be in good condition, with no visible deterioration (Photo 26). No pond discharges have ever flowed through the spillway.

Photo 26: Units 1 & 2 STEP Dam: Emergency spillway, looking downstream.

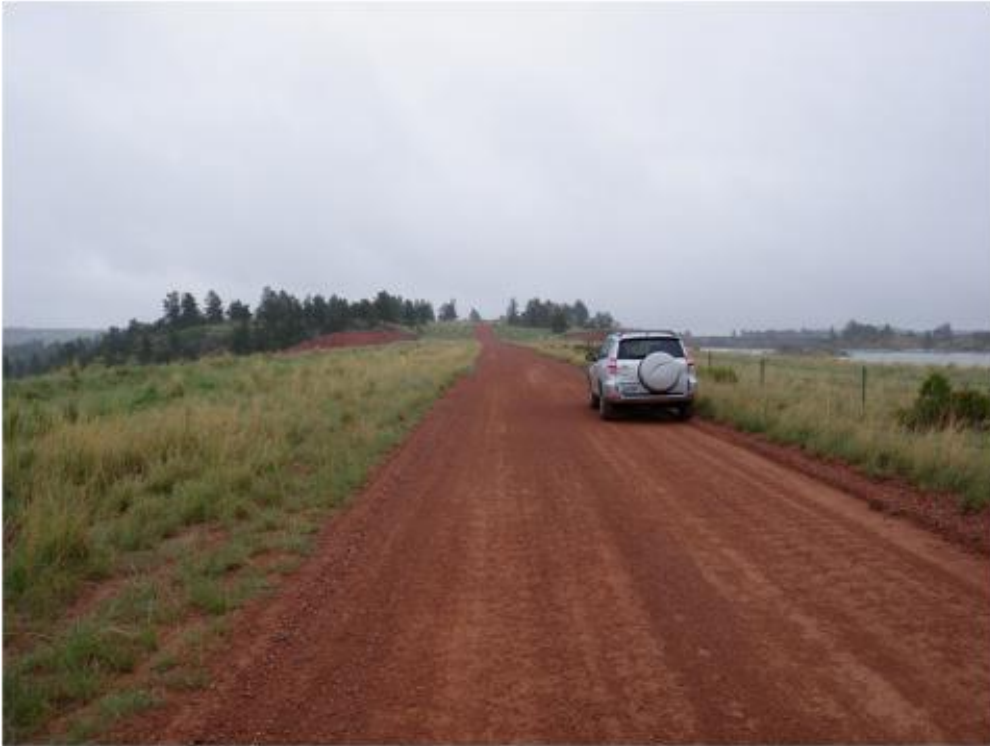
Photo 27: Units 3 & 4 EHP Main Dam: View of very wide dam crest from left abutment, looking to the right. The Old Clearwell cell is on the upstream side.

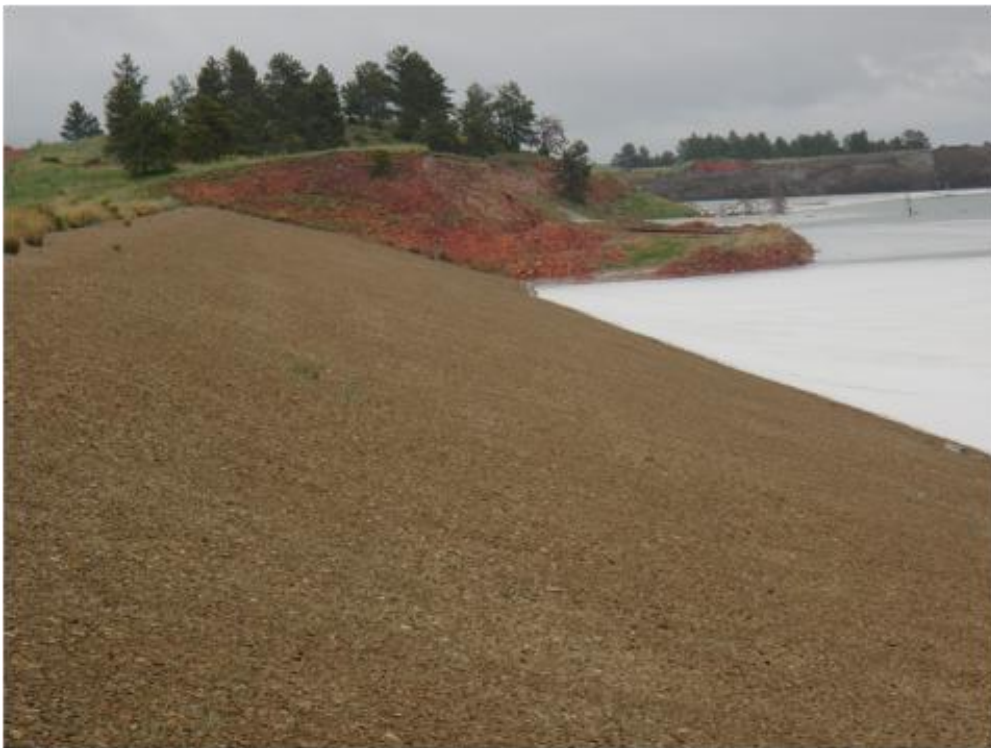
The upstream slope of the Main Dam is protected by soil cement and appeared to be generally in satisfactory condition (Photo 29 and 30). Some seepage and erosion was observed at the left abutment groin on the upstream slope. The seepage was located more than 10 feet above the reservoir water level. Ray Womack of Womack Consulting indicated that the seepage originates from perched groundwater within the dam abutment and the adjacent divider dike due to the recent rain (Photo 31). This seepage location was also acknowledged in Womack's 2009 report. The report indicates that the seepage originates due to surface water collecting in the baked shale and has no effect on the stability of the dam.

Photo 29: Units 3 & 4 Main Dam: Looking to right from the left abutment – upstream slope with soil cement protection that impounds the Old Clearwell.

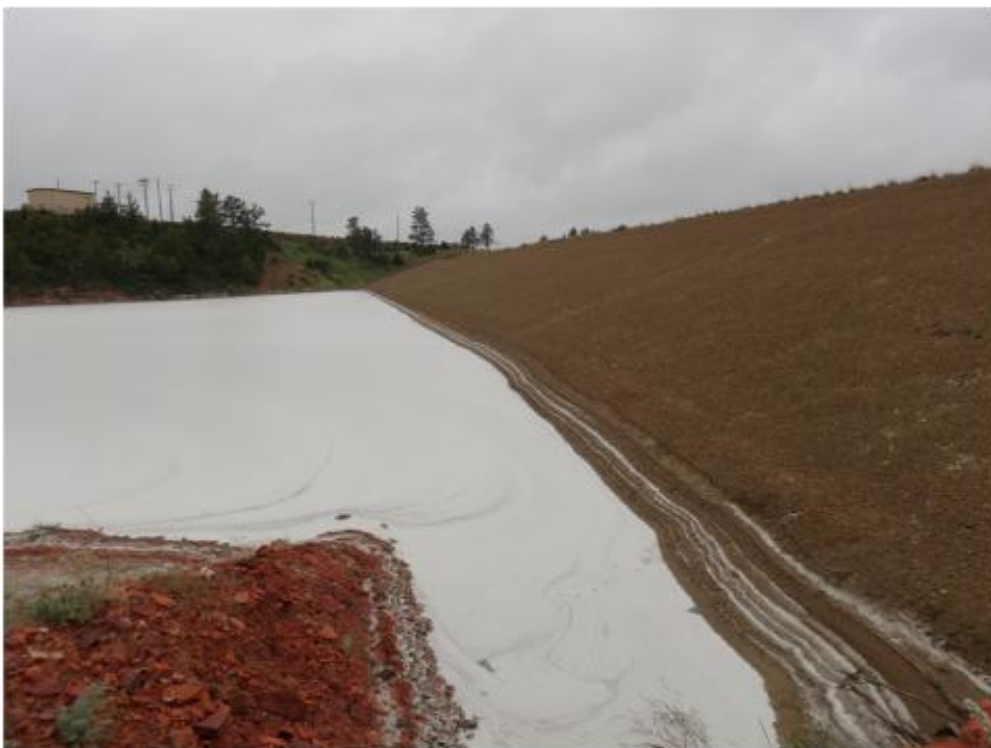
Photo 30: Units 1 & 4 Main Dam: Looking to left from the right abutment – upstream slope with soil-cement.

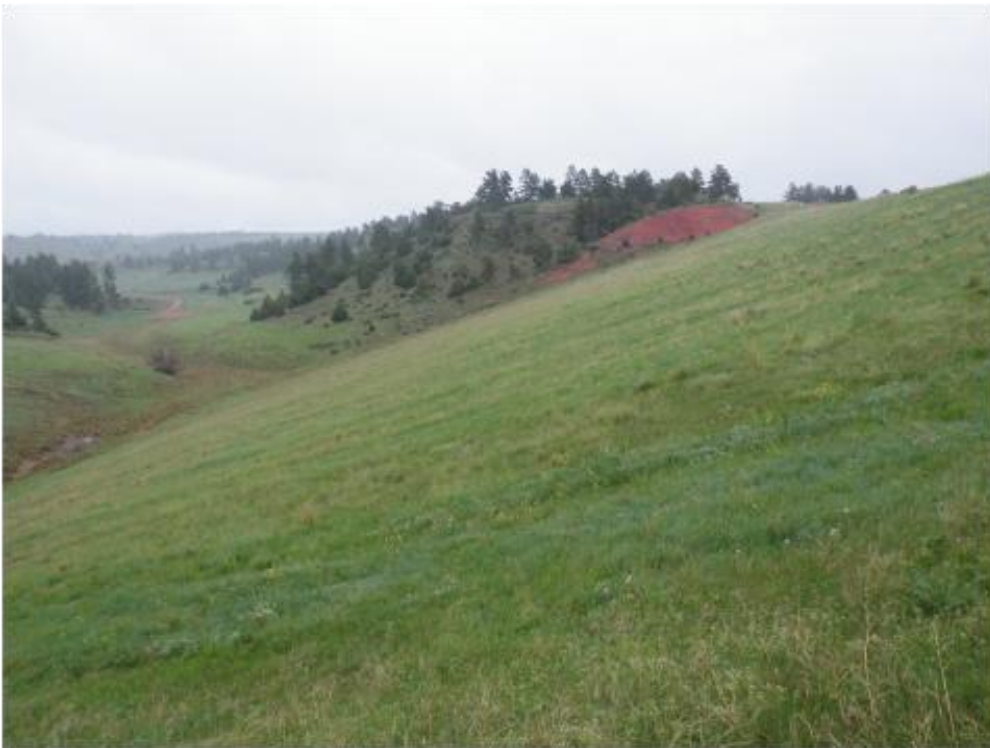
The downstream slope of the embankment is well-vegetated, which provides some erosion protection (Photos 32 and 33). No signs of major instability were observed along the downstream slope. Some animal burrows, including one excavated into the drainage sand at the right downstream groin, and minor erosion rills caused by surface water were observed (Photos 34 and 35). Seepage has been observed in the natural ground a short distance downstream of the Main Dam since 2000 (Womack 2009) and studies have shown the flow

Photo 32: Units 3 & 4 Main Dam: Looking to right at the downstream slope from left abutment.

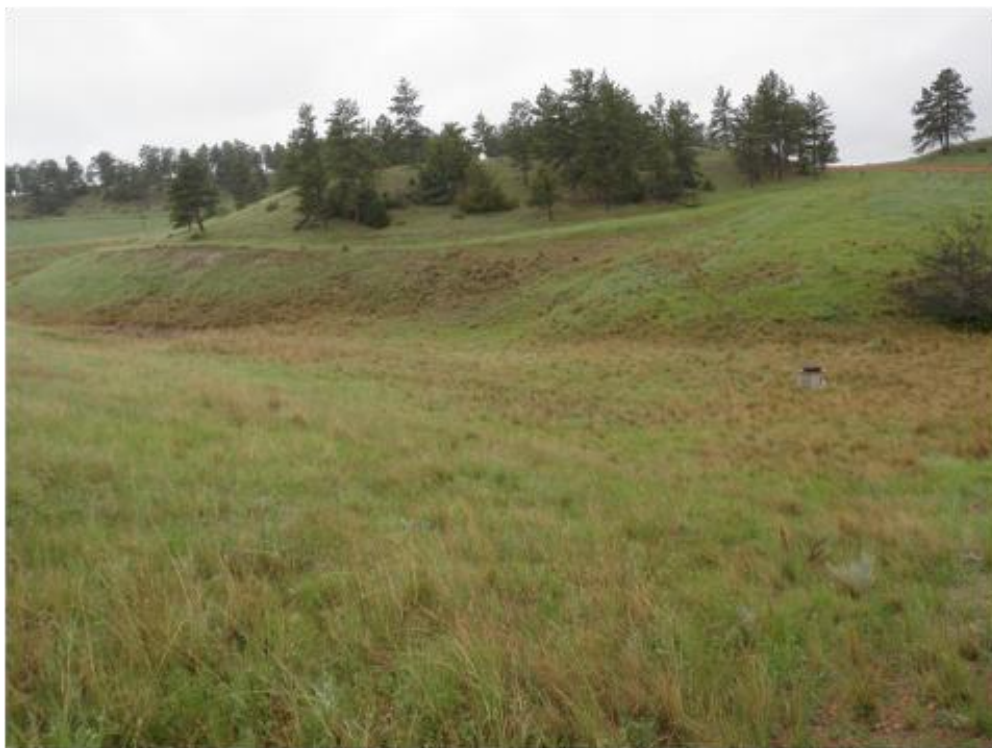
Photo 33: Units 3 & 4 Main Dam: Looking to left at downstream slope and toe from the right groin area.

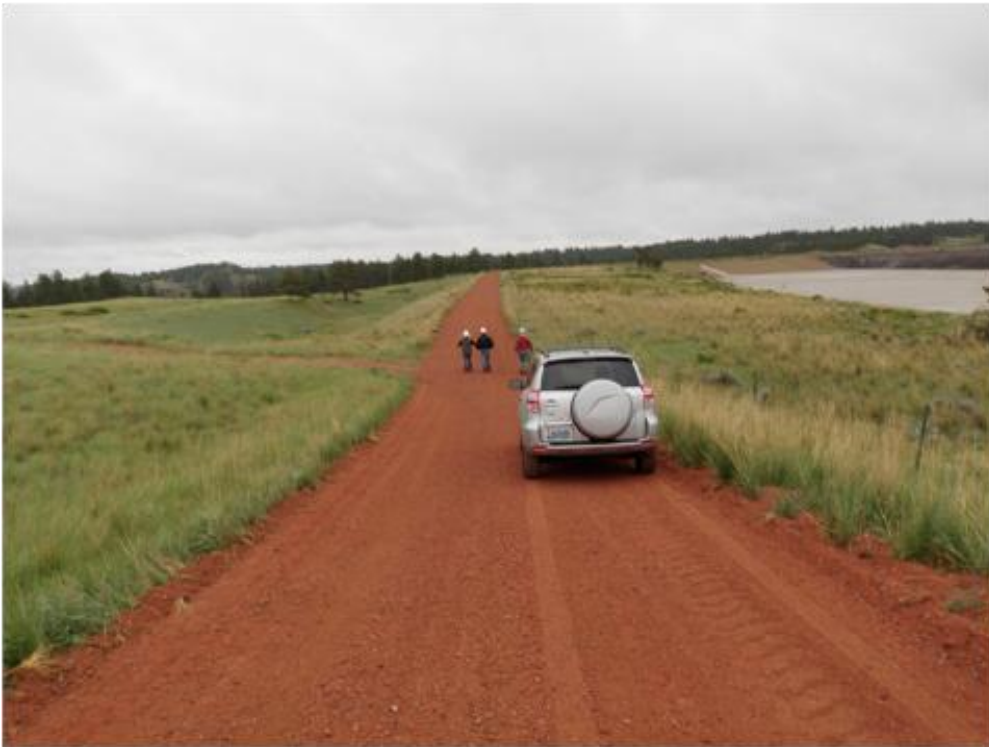
The embankment crest appeared to be in fair condition. Because the dam will be raised in the future, the crest is currently wider than its proposed 20 feet. There is a dirt road along the downstream side of the crest, (Photo 36) while the upstream side is vegetated with a thick stand of sage brush and grass (Photo 37). PPL Montana personnel pointed out healed cracks in areas where cracking and settlement occurred associated with the 1999 seepage event (Photos 38 and 39). Cracks up to about 1 foot wide and several feet deep were originally observed during the inspection by Maxim Technologies in 1999 (Maxim, 2005) and have since been repaired. No new damage was observed beyond that documented in the past.

Photo 36: Units 3 & 4 Saddle Dam: View of very wide dam crest from the left abutment, looking to the right. Cell "G" is impounded to the right.

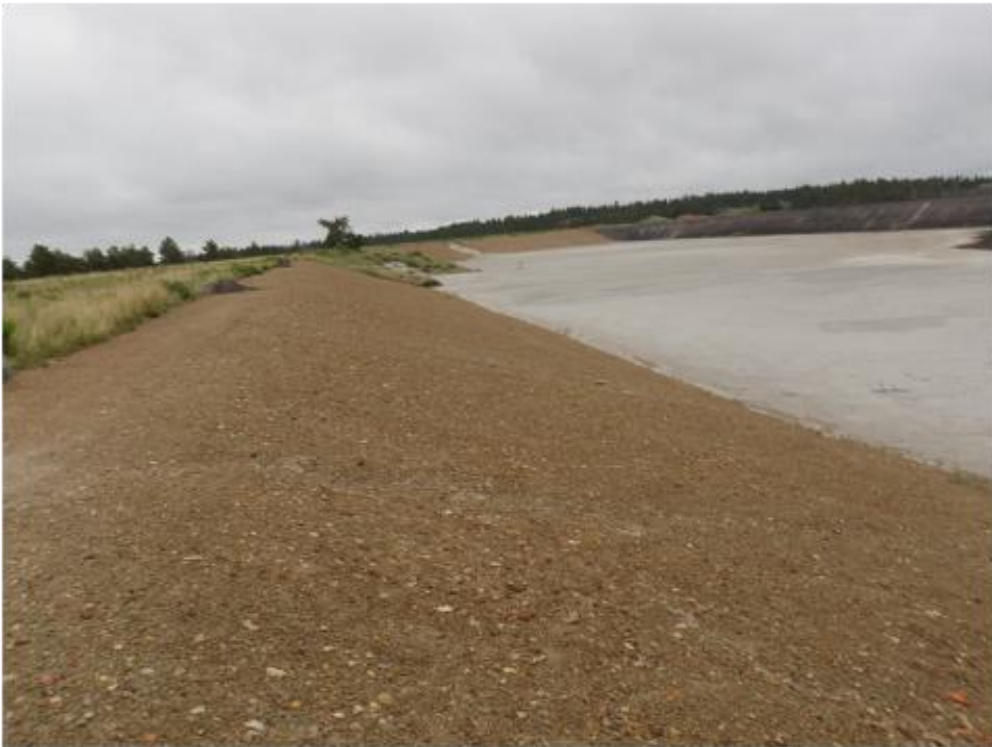
The upstream slope of the dam is protected by soil cement and appeared to be in good condition (Photo 40). Minor vegetation was becoming established on the soil cement in some areas (Photo 41).

Photo 40: Units 3 & 4 Saddle Dam: View of upstream slope from near the left abutment. Note soil-cement erosion protection.

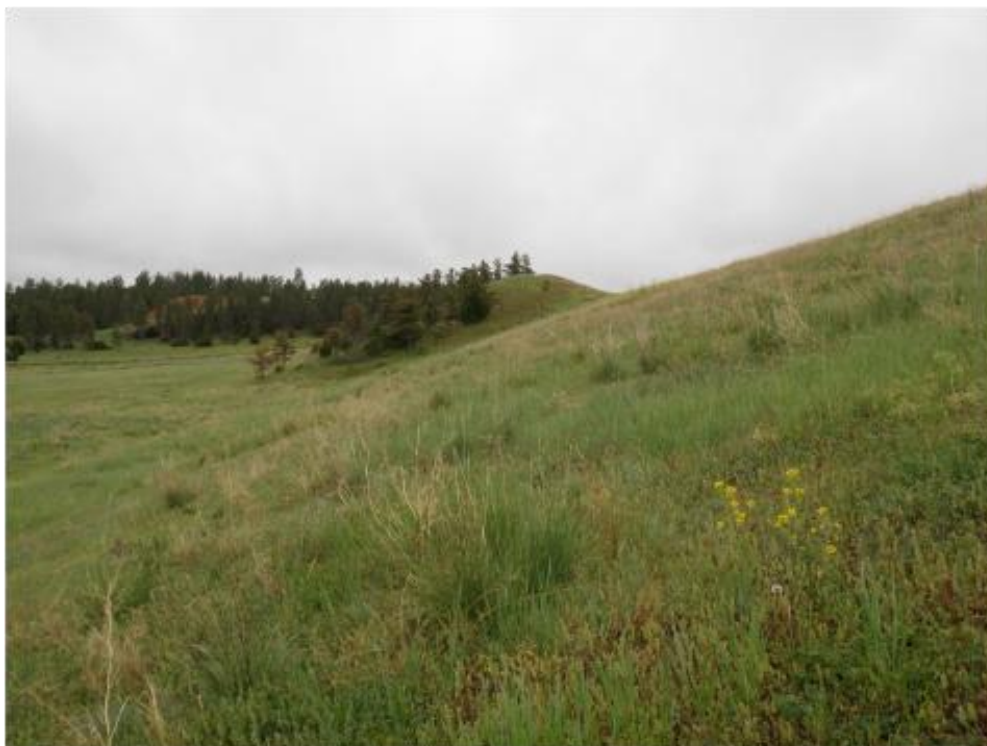
The downstream slope of the embankment is well-vegetated, which provides some erosion protection (Photos 42 and 43). Several issues were noted during the field assessment of the downstream slope. Near the center of the dam at the downstream toe was an open test pit (Photo 44) that was excavated about 10 years ago to observe the toe drain during the 1999 seepage event. The drain sand and a broken toe drain pipe were visible in the test pit

Photo 42: Units 3 & 4 Saddle Dam: View of downstream slope looking to the right.

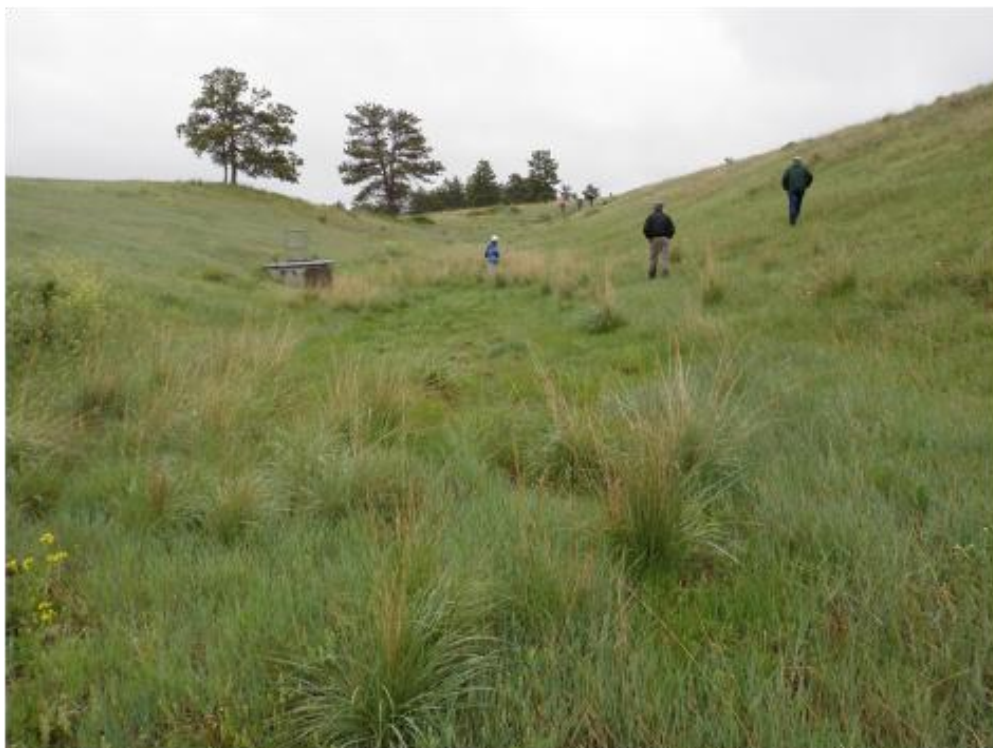
Photo 43: Units 3 & 4 Saddle Dam: Downstream toe near left abutment.

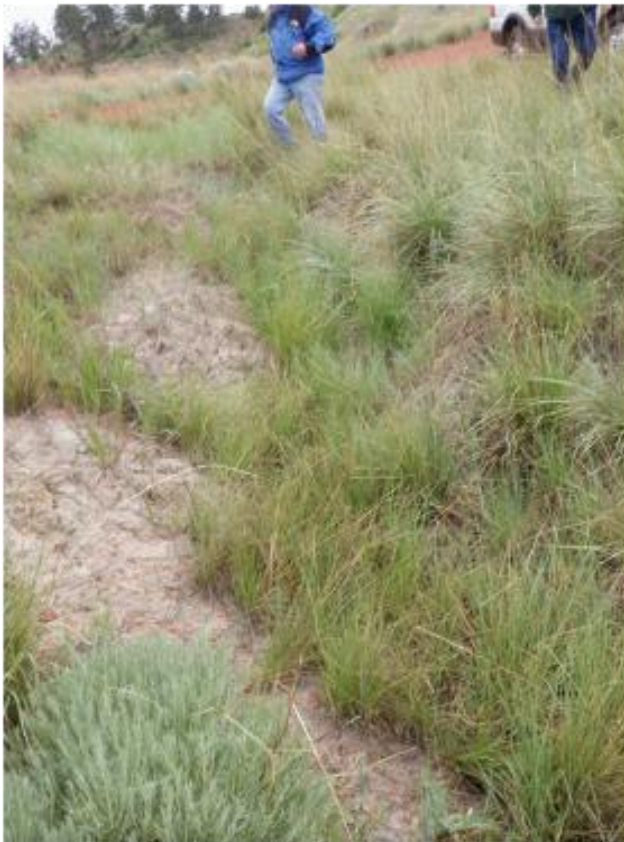
(Photo 45). PPL operates the adjacent cell “G” with a restricted water level below El. 3,237 to prevent recurrence of the seepage issue. Some minor surface erosion was also observed along the downstream slope (Photo 46).

Photo 46: Units 3 & 4 Saddle Dam: Surface erosion near crest at left abutment/downstream groin.
